EPA/OSHA JOINT CHEMICAL ACCIDENT INVESTIGATION REPORT

**Surpass Chemical Co., Inc.
Albany, NY**

Accident Investigation Report
Surpass Chemical Company, Inc., Albany, New York, April 8, 1997

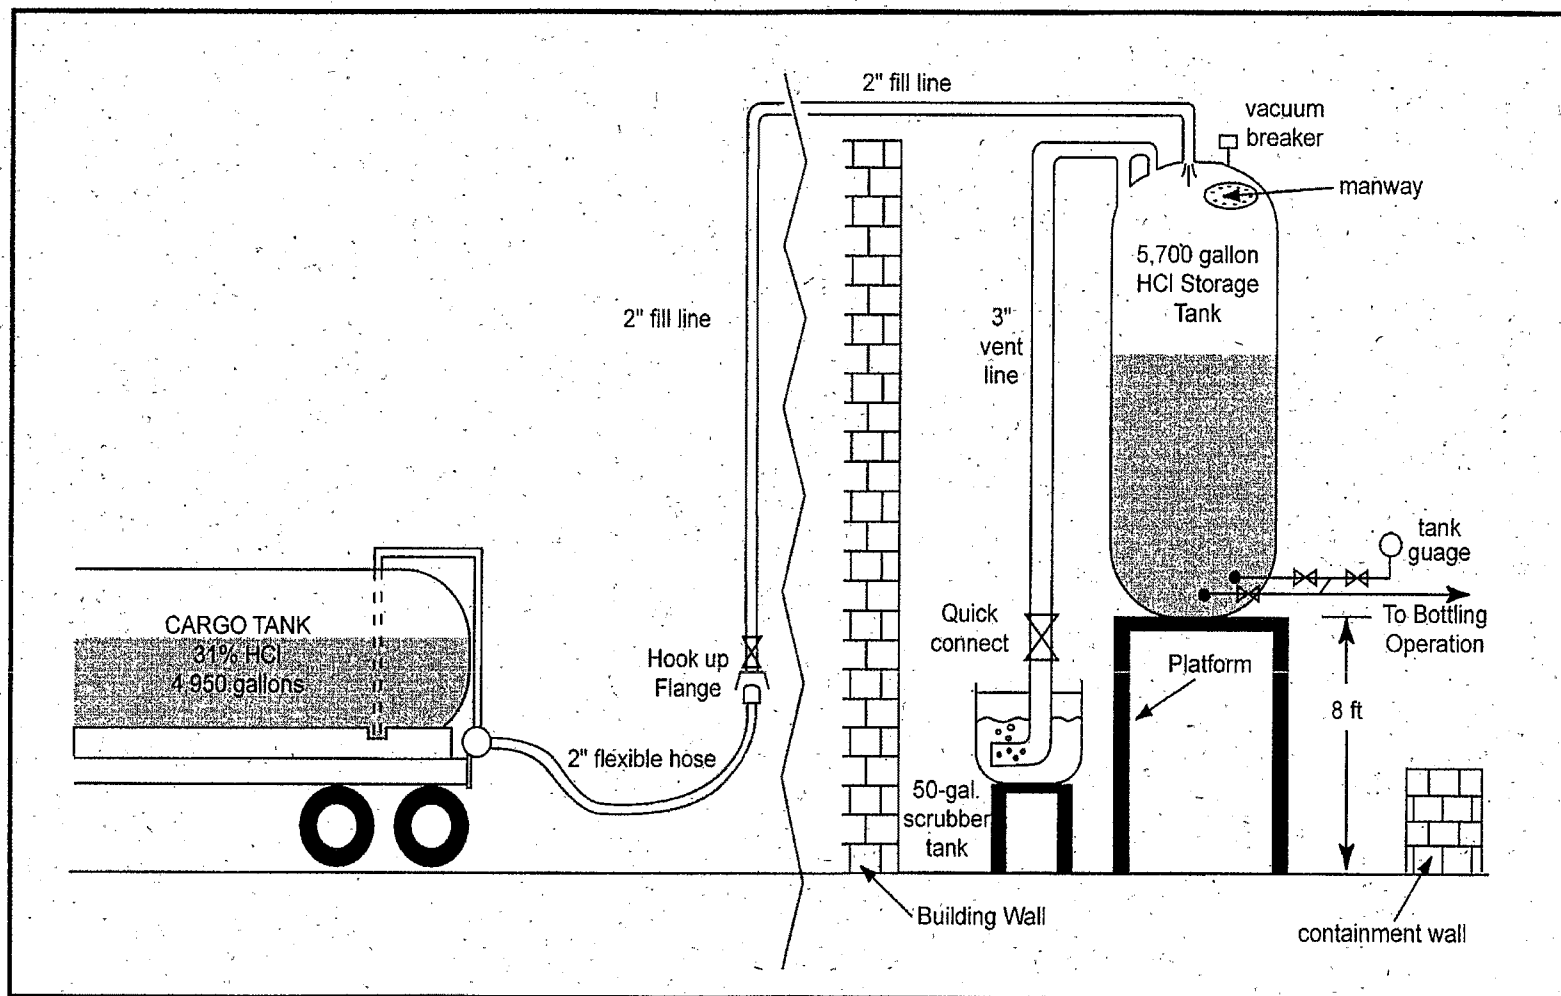
Figure 2: Representation of Offloading Operation
(not to scale)

The diffuser sat in a 50-gallon, loosely-covered plastic drum referred to as the scrubber tank. (The scrubber system is shown in **Figure 2**.) Initially, the tank was filled with sodium

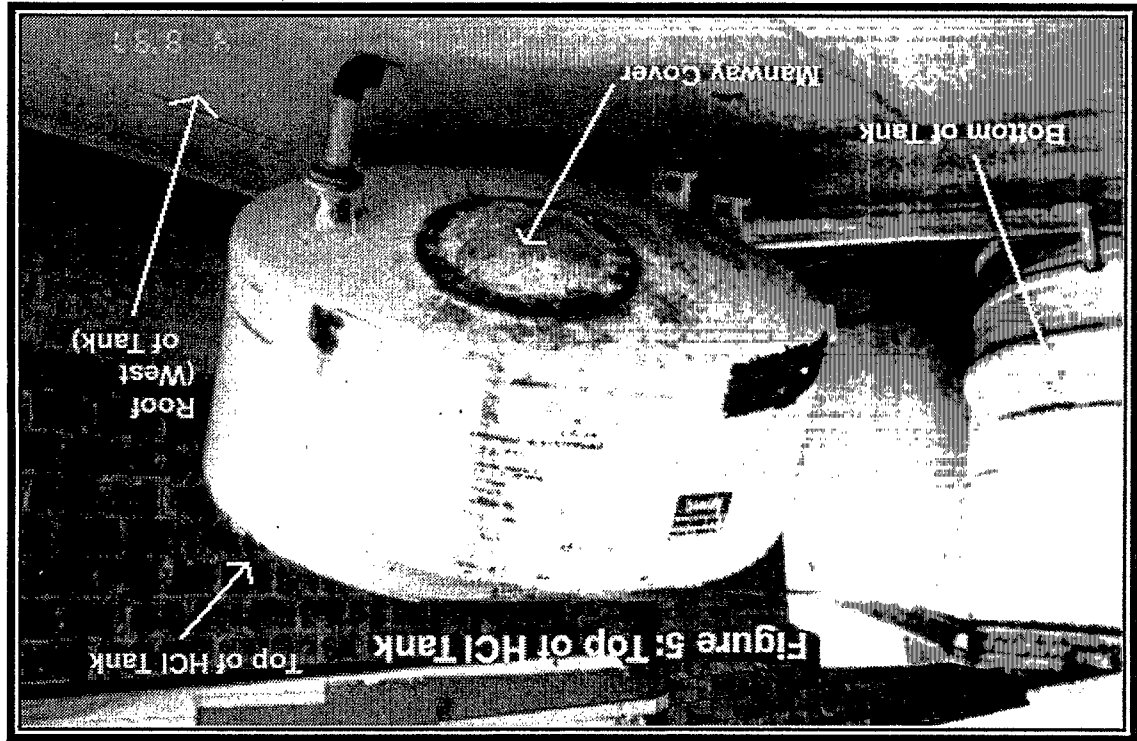
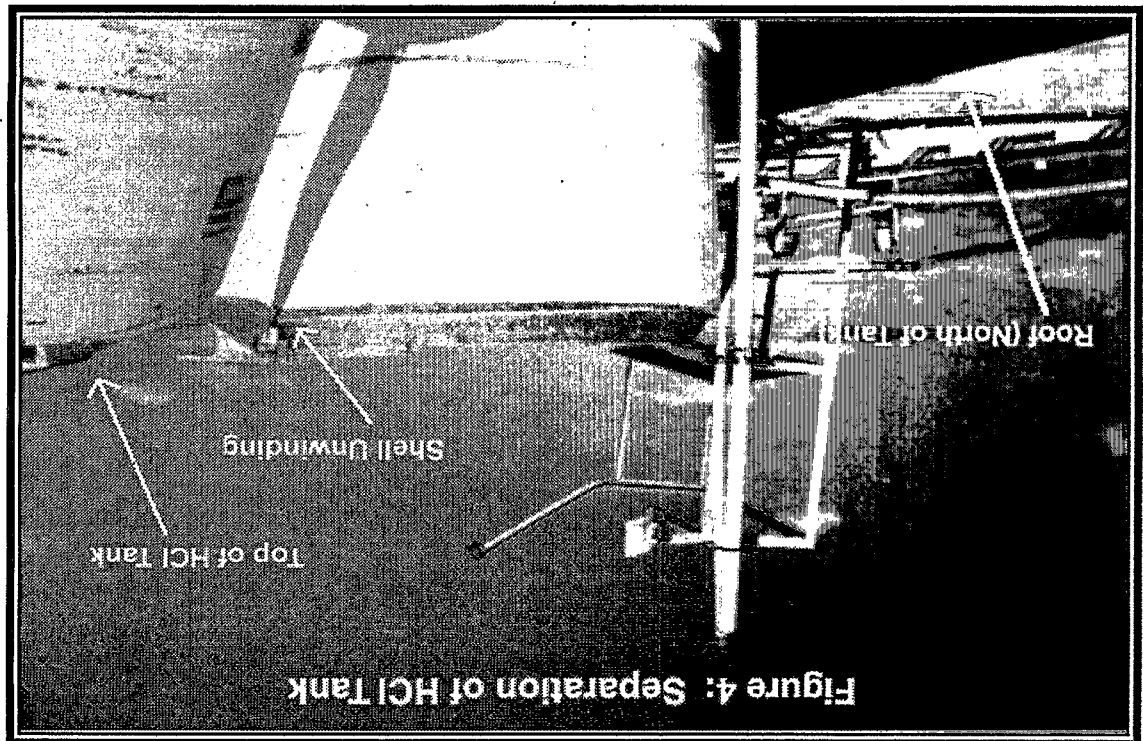
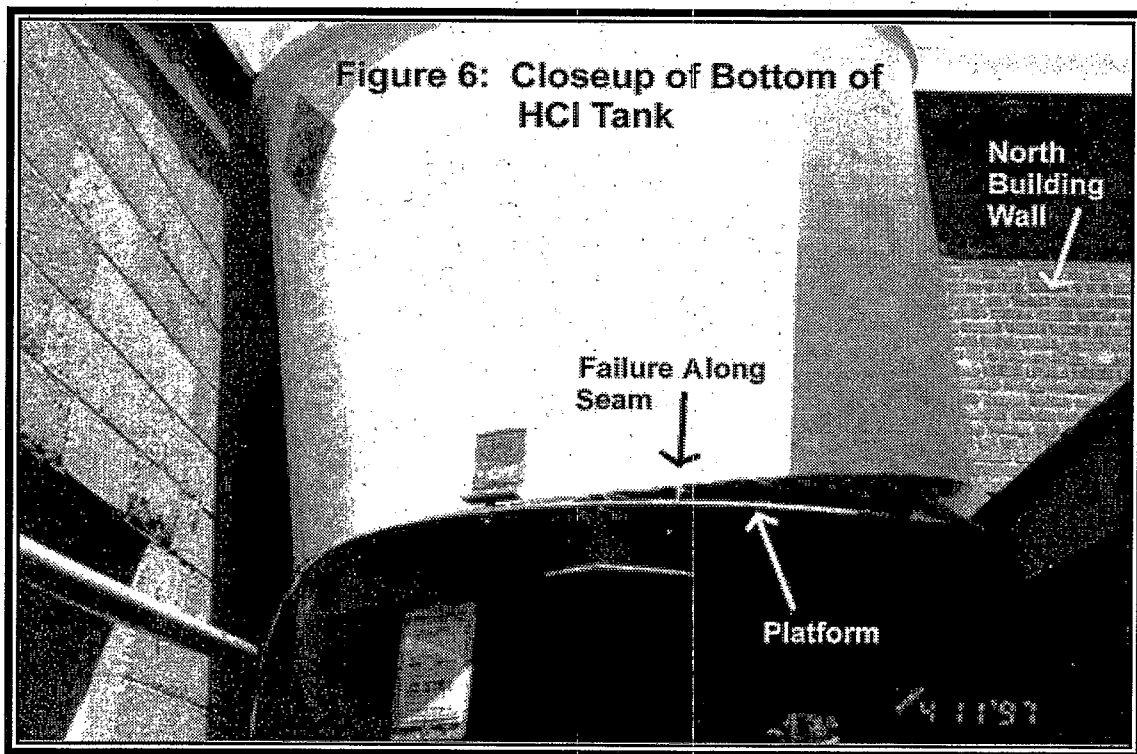
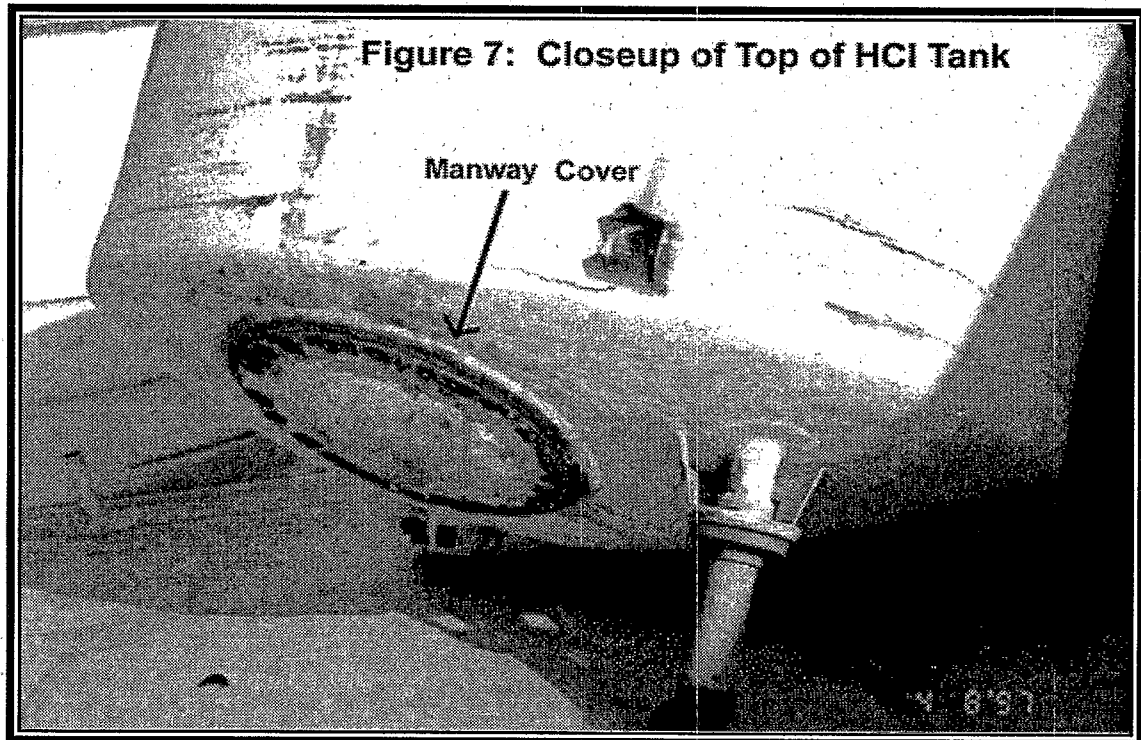
The HCl tank head separated at a point about 5 feet from the top of the tank and flew about 15 feet west to the roof of an adjacent building. **Figure 4** shows the separated tank after the incident, and **Figure 5** shows the top of the tank. The bottom of tank failed in the knuckle area where the cylindrical part of the HCl tank meets the flat bottom, as shown in **Figure 6**. The tank bottom remained on the platform. The cylindrical part of the fiberglass shell began to unwind itself at the top edge (see **Figures 4 and 5**). The shell also remained on the platform but collapsed, leaning toward the west building wall (see **Figure 6**). The scrubber tank was not affected by the tank failure; it was found intact in its original position after the incident, as shown in **Figure 7**.

At the time of rupture, the HCl tank contained about 4,800 gallons of material. The failure of the HCl tank caused a sudden surge of liquid over the secondary containment wall. The force of the liquid also caused a break in the masonry of the secondary containment wall. Surpass has estimated that as a result of this release, about 150 gallons were absorbed by soil within the property boundary and about 2,300 gallons entered storm drains located on Broadway. The storm drains emptied into an underground stream, the Patroon Creek, a tributary of the Hudson River. Surpass also estimated that 1,900 gallons were contained within the secondary containment dike and that 400 gallons entered a nearby building through a window in the north wall and through an exhaust fan in the west wall.

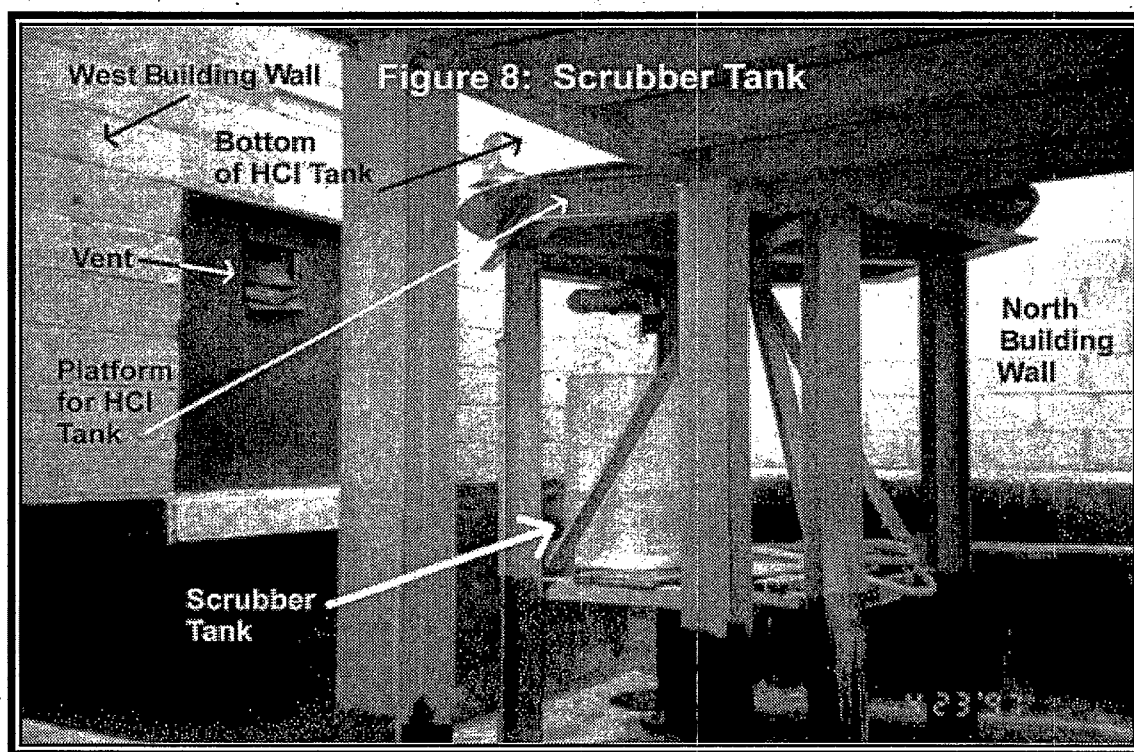
- The scrubber tank was not affected by the tank failure; it was found intact in its original position after the incident. (See **Figure 8**.)
 - After the incident, the diffuser in the scrubbing tank was removed by disconnecting the vent line quick connect and removing the lid from the scrubber tank. The holes in the diffuser were found to be clogged with a white crystalline substance, as shown in **Figure 9**. This substance was sodium chloride, according to laboratory analysis.

- A layer of white crystalline material was also found in the bottom of the scrubber tank. This substance also was sodium chloride, according to laboratory analysis.

Surpass and other facilities should maintain environmental control systems to ensure continuous reliability and effective operation. Based on the system design, the known failure history, and engineering judgement, Surpass and similar facilities should evaluate how long the scrubber solution can be used before it needs to be replaced; develop detailed procedures for inspecting, testing, and adjusting the scrubber solution-- including the frequency of tests, the parameters (pH, specific gravity, etc.) to be measured, and the acceptable range of those parameters; and establish control mechanisms to ensure that preventive maintenance is performed correctly. Maintenance procedures should be written. Maintenance results should be documented in order to provide a historical basis for revising the procedures.

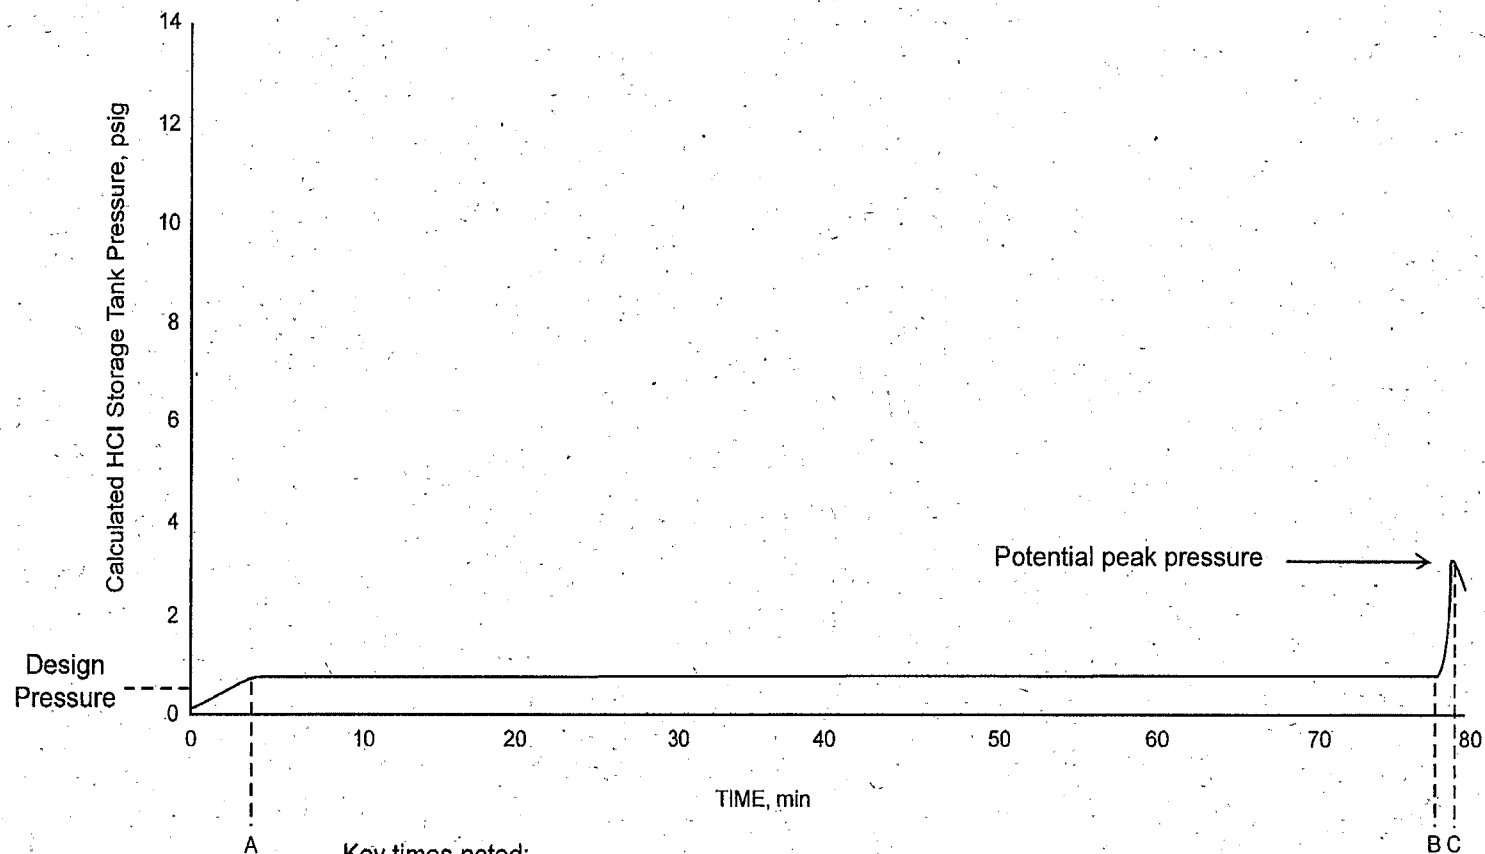
Figure 10
Modeled HCl Storage Tank Pressure
Scenario: No Fouling of Diffuser Openings

- A - HCl storage tank pressure exceeds hydrostatic pressure of solution in scrubber tank.
- B - Pressurized air from truck's cargo tank flows into HCl tank.
- C - Potential peak pressure as modeled for scenario.

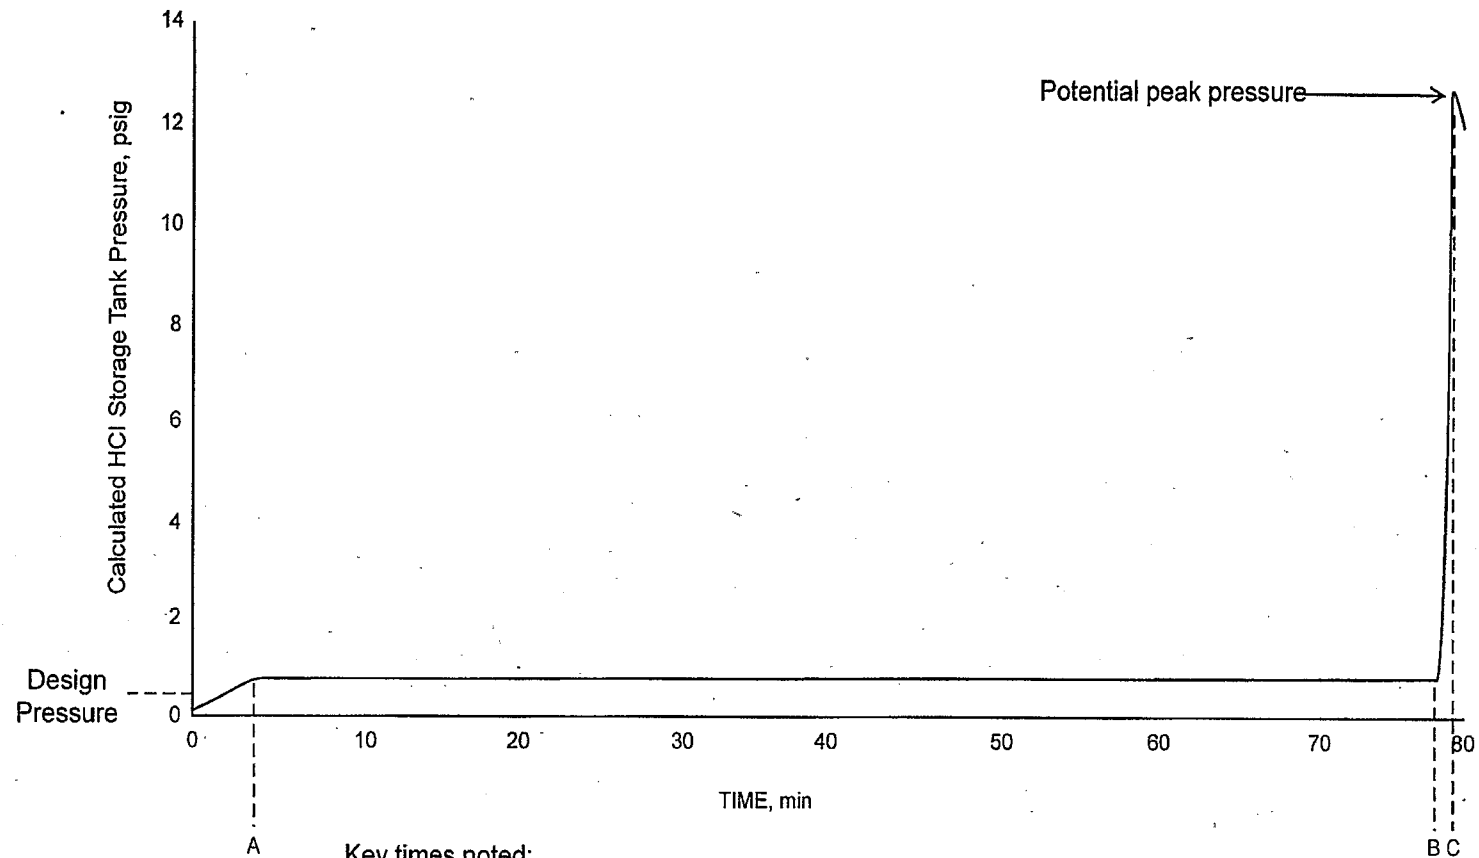
Figure 11
Modeled HCl Storage Tank Pressure
Scenario: 84% Fouling of Diffuser Openings

- A - HCl storage tank pressure exceeds hydrostatic pressure of solution in scrubber tank.
- B - Pressurized air from truck's cargo tank flows into HCl tank.
- C - Potential peak pressure as modeled for scenario.
